Case Study

Remediation of a Former Paper Mill

Linden Homes

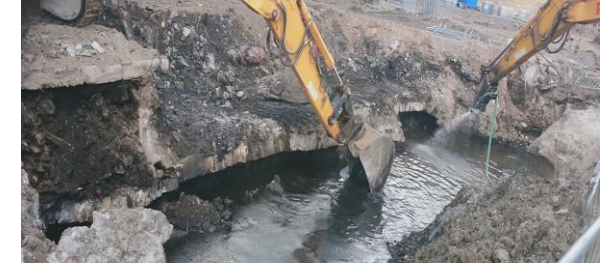
Flocculant addition to hydrocarbon impacted organic sludge to dewater for handling before further ex-situ treatment.

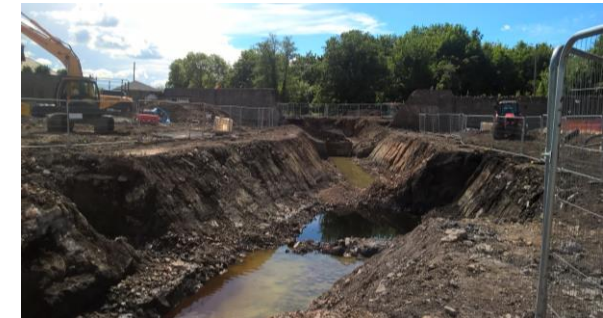
Removal of contaminated tunnel system prior to benching and reinstatement with remediated materials.

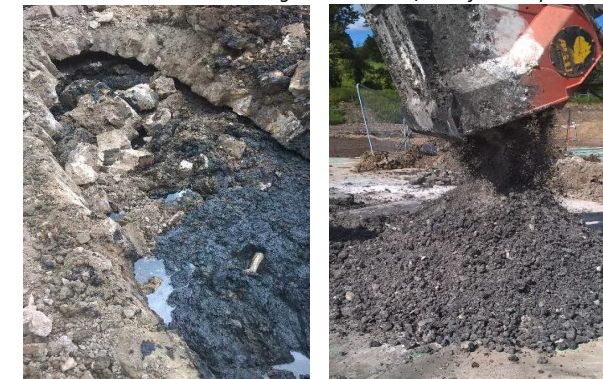
Hydrocarbon impacted organic sludge (left) was first dewatered in situ and then remediated using a stabilisation/solidification process.
