# Case Study

## Remediation of Infilled Gas Works Waste

Major UK Housing Provider

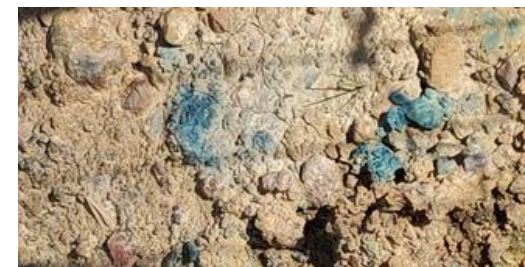
Former farmland on which 300+ housing units were under construction. During development a historic pond was discovered to have been infilled with gas works waste to a depth of 4m, containing very high levels of contamination. The infilled pond was located beneath proposed houses and gardens.

- Cyanide - >10,000mg/kg
- Hydrocarbons
- Poly Aromatic Hydrocarbons
- Lead
- Ammonia

Figure 1 – “Blue Billy” ferricyanide visible at the surface following the topsoil strip.

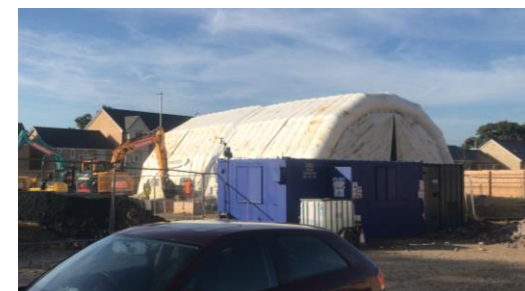
Figure 2 – Inflatable tent used to contain emissions.

- Excavation of >850 tonnes of heavily impacted material, successfully stabilised for handling and consigned to a licensed facility.
- All works completed inside a large inflatable tent under negative air pressure to contain fugitive emissions, with clean air feed PPE system and HVAC with air scrubbing exhaust system.

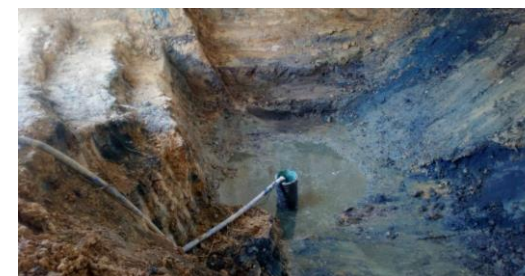
Figure 3 – controlled dewatering of the excavation.

- Dewatering and disposal to a licensed treatment facility of 24,000 litres of impacted groundwater.
- Careful segregation and waste classification during the works minimised the overall disposal costs.
