Case Study

Remediation of hydrocarbon impacted soils and water

Kier Construction Ltd

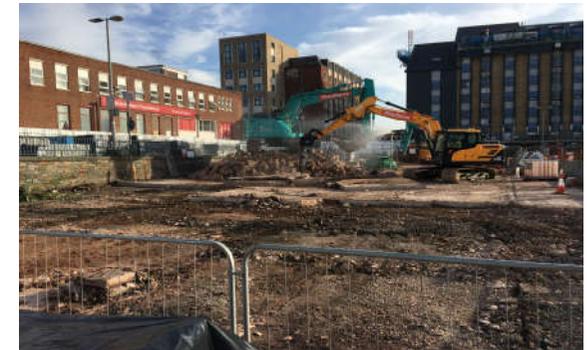
Figure 1: Safe excavation of concrete slab

- Use of floor sawing to safely excavate concrete slab without damage to potential underground services.
- Use of VacX no dig technology to uncover live services for disconnection
- Mobilisation of a water treatment system to treat impacted water onsite prior to discharge to foul sewer under a discharge consent.
- Ex-situ treatment of impacted made ground at UKRL soil treatment facility.
- Further investigation of underlying soils behind retaining wall.
- Installation of impermeable barrier to prevent water ingress from offsite sources during dewatering.
- Working closely with various sub-contractors onsite to ensure programme delivery.

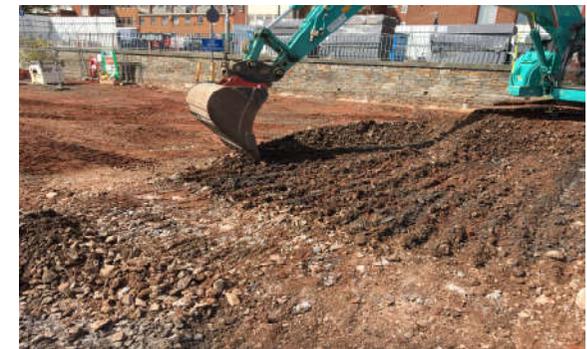
Figure 2: Excavation of hydrocarbon impacted made ground

- Safe excavation and offsite disposal of concrete slab and coal tar impacted tarmac.
- Excavation of impacted made ground for offsite disposal to UK Remediation Exeter Soil Treatment Facility for ex-situ treatment.
- Drilling of boreholes for dewatering and monitoring.
- Onsite water treatment system for treatment of impacted perched water prior to discharge to foul sewer under a discharge consent.
