Case Study

Stabilisation-Solidification of TPH Contaminated Organic Sludge

Linden Homes

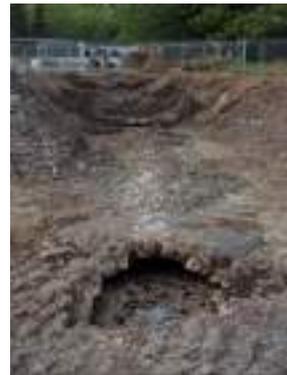
Excavated tunnel crown running to the river (beyond the trees), showing oil/water/sludge mix within.

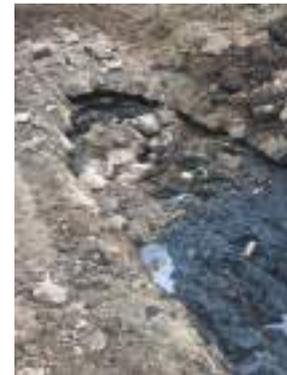
Partially dewatered oily sludge after removal of free oils and coagulant/flocculant addition.

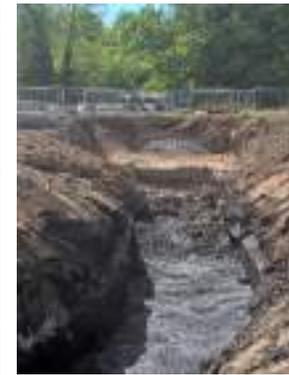
Fully dewatered tunnel with dewatered sludge awaiting removal to the site treatment area.

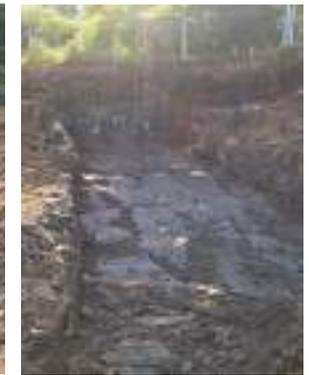
Having removed all below-ground obstructions, voids were backfilled using the stabilised and solidified material.
