Case Study

Residential Redevelopment of a Historic Mill

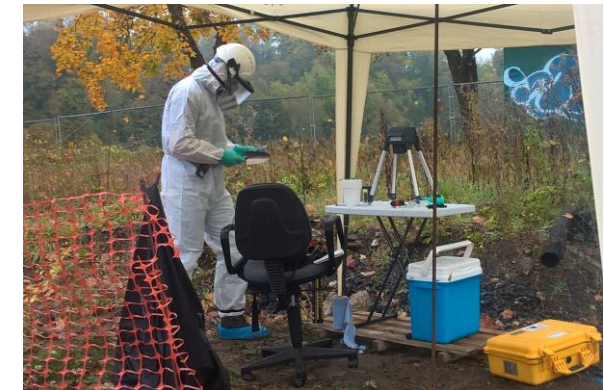
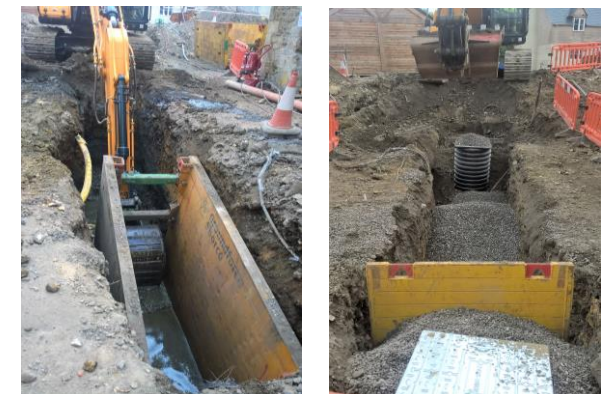
Excavation (left), installation and reinstatement (right) of free product recovery trenches facilitated removal of viscous heavy oil from beneath the retained historic buildings.

- Selective recovery of oil free product, using an in-ground skimming system, deployed between buildings in wells and trenches, to minimise groundwater abstraction and treatment needs.
