**CASE STUDY**

**CHIPPENHAM, TANK REMOVAL**

Client	Redcliffe Homes
Location	Chippenham
Remediation Value	£7,000
Project	Removal of liquids, supervision of excavations and disposal of contaminated soils
Contaminant	Diesel

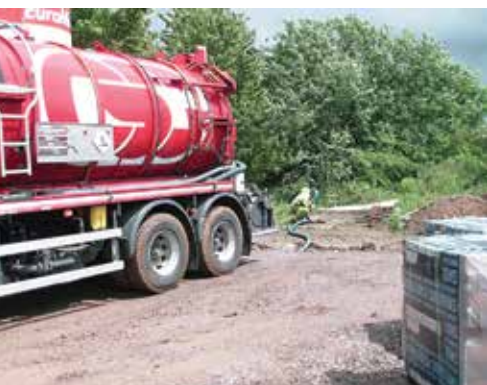
Tank being pumped out prior to excavation

UK Remediation arranged for a vacuum tanker to attend site and remove the liquid after which the tank was excavated along with any visually obvious impacted soils. These were stockpiled adjacent to the excavation on an area of existing concrete hard standing.

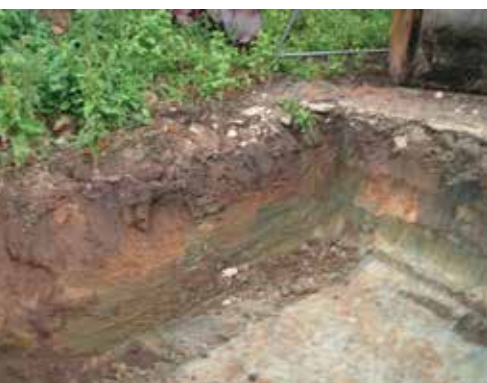
Completed tank removal excavation

Validation samples were then collected from the excavation along with waste classification samples from the stockpiled soils.

The validation results identified that some minor elevated TPH concentrations remained and as the tank was located in the vicinity of a garden, UK Remediation returned to site and removed these soils. The excavation was then revalidated, which confirmed the impacted soils had been removed.
