Case Study

Ex-Situ Bioremediation of Hydrocarbon Impacted Soil

Halsall Construction

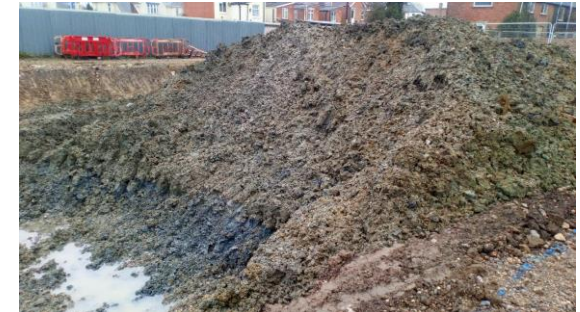
Figure 1: Excavation of hydrocarbon impacted material

- Targeted 'hotspot' excavation based upon site investigation data, with further delineation during excavation work.
- Construction of a 'treatment bay' using existing site won materials.
- Application of a biostimulant and bioaugmentation solution to the impacted soils to promote indigenous microbial activity to achieve the degradation of heavy chain hydrocarbons in order to shorten the treatment period.
- Ensuring optimal conditions for microbial activity.
- Application of chemical amendments to break up the soil matrix to allow aeration.
- Validation sampling to confirm the suitability of the material for reuse onsite as engineered fill by others.

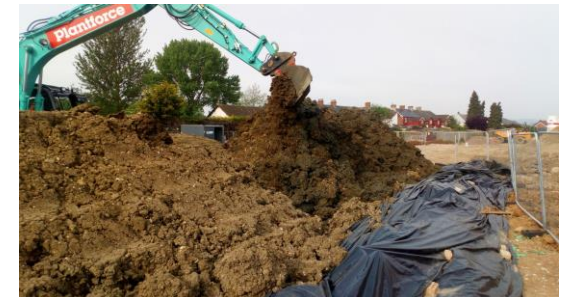
Figure 2: Treatment of impacted material

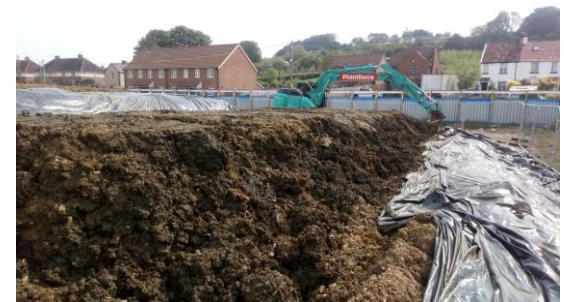
Figure 3: Windrows of impacted material within treatment area
